THE BRUKSWICK

A CONTROVERSIAL MEGASTRUCTURE

Abstract

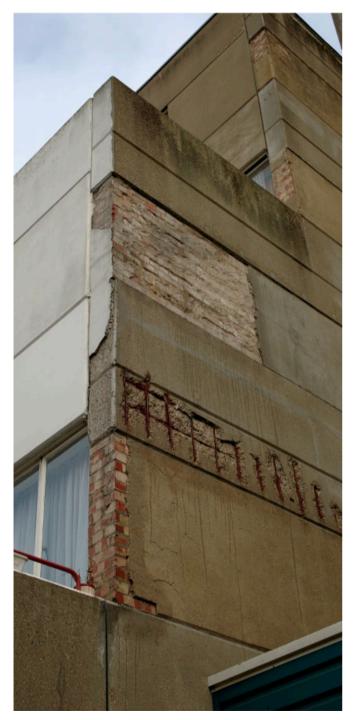
The cost-cutting measures resulted in the heavily-compromised buildings 11. Flaws can be found all around the flats, such as the omission of retractable glazed roofs over the balconies, the frequent leaks at the junctions below door thresholds, a problem of water penetration due to the shallow asphalt of drainage, and leaks between balconies resulting from inadequate maintenance to the mastic ⁷ (Figure 5). The more evident that the compromise was 'Crown Commissioner's cream' painting of the elevations was replaced, leaving corroded and cracked surfaces 7 (Figure 4), which aggravated the feeling of dilapidation.

- Figure 4. The corroded and cracked surface before refurbishment ⁶
- Figure 5. Leakage seen everywhere in the Brunswick
- Figure 6. 'Concrete jungle' of the Brunswick

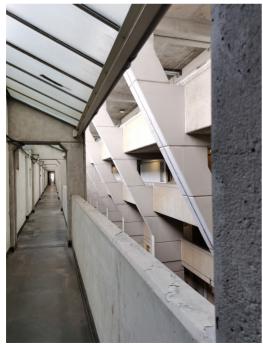
- Figure 7. Proliferation of concrete structures
- Figure 8. The A-frame structures formed by the stepping back of flats
- Figure 9. An illustration of the zoning for the Brunswick. The upper part is the housings, and the lower part is the retails including shops, restaurants and a cinema.

One is the tremendous volume of the project. The Brunswick is frequently described as 'concrete jungle' (Figure 6), which describes the mega scale of the architecture, the labyrinth-like routes and the proliferation of concrete elements ¹⁵ (Figure 7). The narrow and tall A-frame structure of the corridors (Figure 8), the vast space on the podiums of the retails and the repeated structures of the flats (Figure 1) are inevitably impressive 15, which is partly why the Brunswick is constantly criticized as 'too imposing and overpowering' 17. However, it is also deemed by some people that the grandeur of the Brunswick could provoke a feeling of awe and a sense of overwhelmingness at the same time ¹⁶, which is maybe what brutalism is trying to convey.

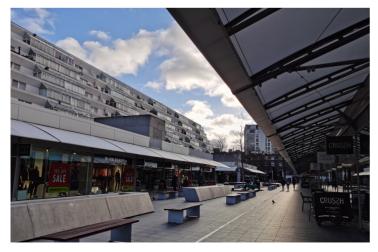
- Figure 13. The 'horizontal' feeling on the shopping street
- Figure 14. The strong 'verticle' feeling in the corridors.
- Figure 15. An illustration of the circulation in the Brunswick. Left: circulation of visitors. Middle: circulation of the residents into rooms. Right: circulation in the semi-private space for residents.

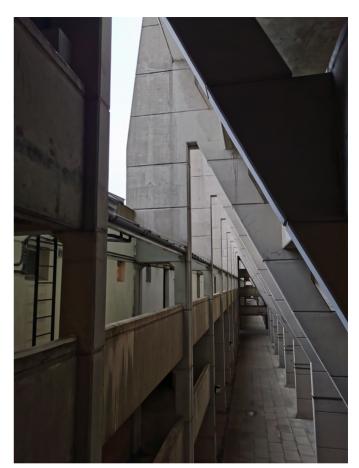
The stepping back of each floor has opened up the shopping street with an enormous sense of light and space 8. At the back it forms a semi-private space with reinforced concrete A-frames, where sunlight naturally sheds into the public corridors that would have been insufficient lighting (Figure 18). To the front it provides a balcony for every flat and guarantees it at least two-hour direct sunshine per day ⁶ (Figure 19). The distinctive 'winter gardens' glint under the sun and give the view of sky from within 24, which according to Sennet 25, have connected life in flats and street activities in contrast to concept that the modernist normal architecture often posit alienation of individuals and the external material world. However for Hodgkinson, the stepped section allowed people to 'live in clouds' that provided an escapement from the quotidian surroundings and an engagement with existential awareness ²⁶.

- Figure 16. View from a balcony to the open space, model constructed in Sketchup
- Figure 17. The 'promenading decks' in semi-private space
- Figure 18 . Sunlight naturally sheds into the corridor.
